Evaluation of Trial Bunker Hill Mine Water Diversion

TO: Cami Grandinetti/USEPA

FROM: Jim Stefanoff/CH2M HILL
Bill Hudson/CH2M HILL

DATE: December 20, 2002

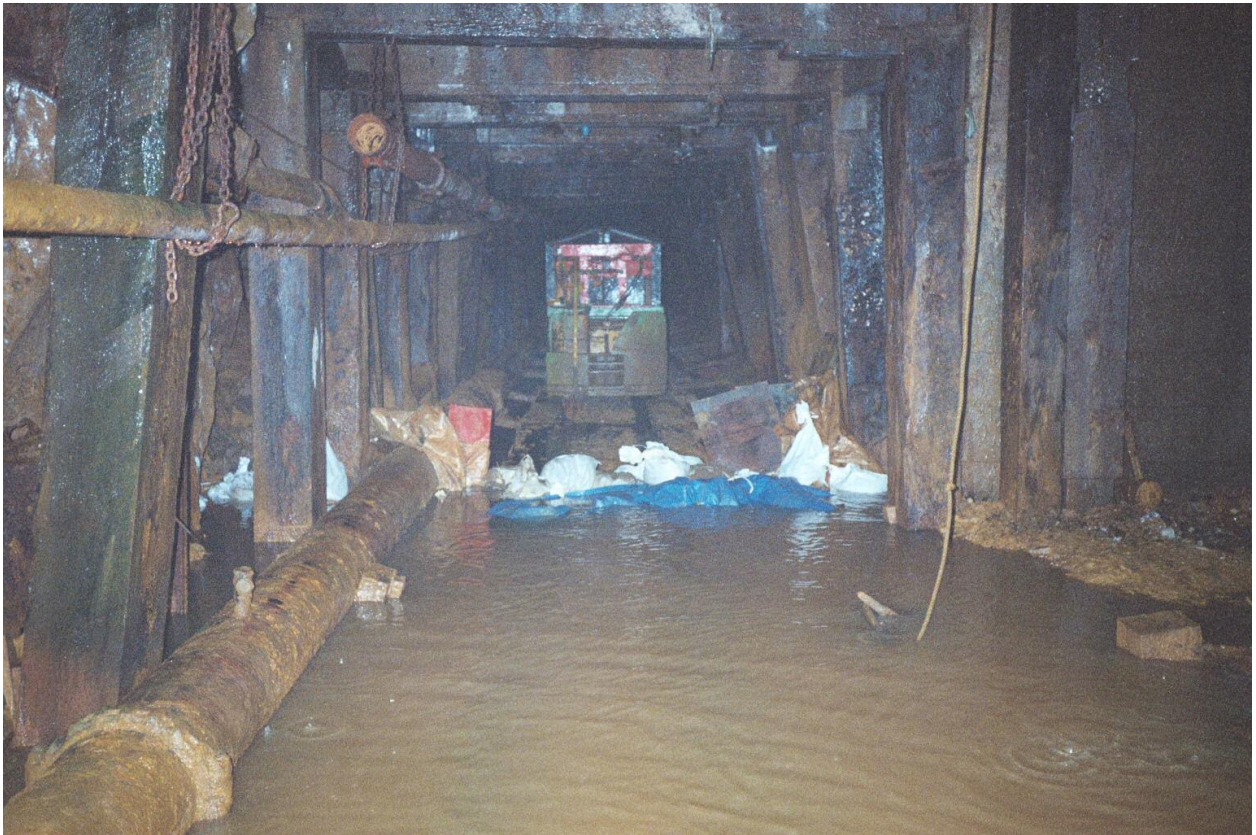
Photo 1

Looking downstream at back of trial diversion dam on 9 Level. The dam is constructed across the Kellogg Tunnel just past (north) of the Barney Switch. The dam is made from sandbags, boards, and plastic tarps. Additional sandbags, boards, and tarps are stored to the right of the photo. The depth of water behind the dam is about 2 feet on the sides, and about 3 inches above the rail in the middle. The flow being dammed is about 1550 gpm. About 50 gpm was leaking through the dam, although this could be readily reduced by another layer of sandbags on the downstream face. The dam would have to be increased in height for higher flows. The reported construction time was 30 minutes.

- The amount of stockpiled diversion building materials should be increased by about 50 percent. This is to ensure an adequate supply for high flows.

- The diversion dam location needs to be kept clean so that the tunnel cross-section is constant. This will reduce dam construction time.
- The Barney Vent Raise should be inspected from the top and bottom a minimum of twice per year, and more frequent if there is doubt concerning its ability to convey up to 7,000 gpm.
- The Barney Vent Raise should be hydraulically flushed at least once per year, and more frequent if needed to provide 7,000 gpm capacity. The flushing volume should be as high as practical. The duration should be as needed for cleanout.
- The mine crew should periodically practice diversion dam construction. Written procedures should be developed by NBHMC and posted at the diversion location. This may be a good time for hydraulically flushing the Barney Vent Raise.

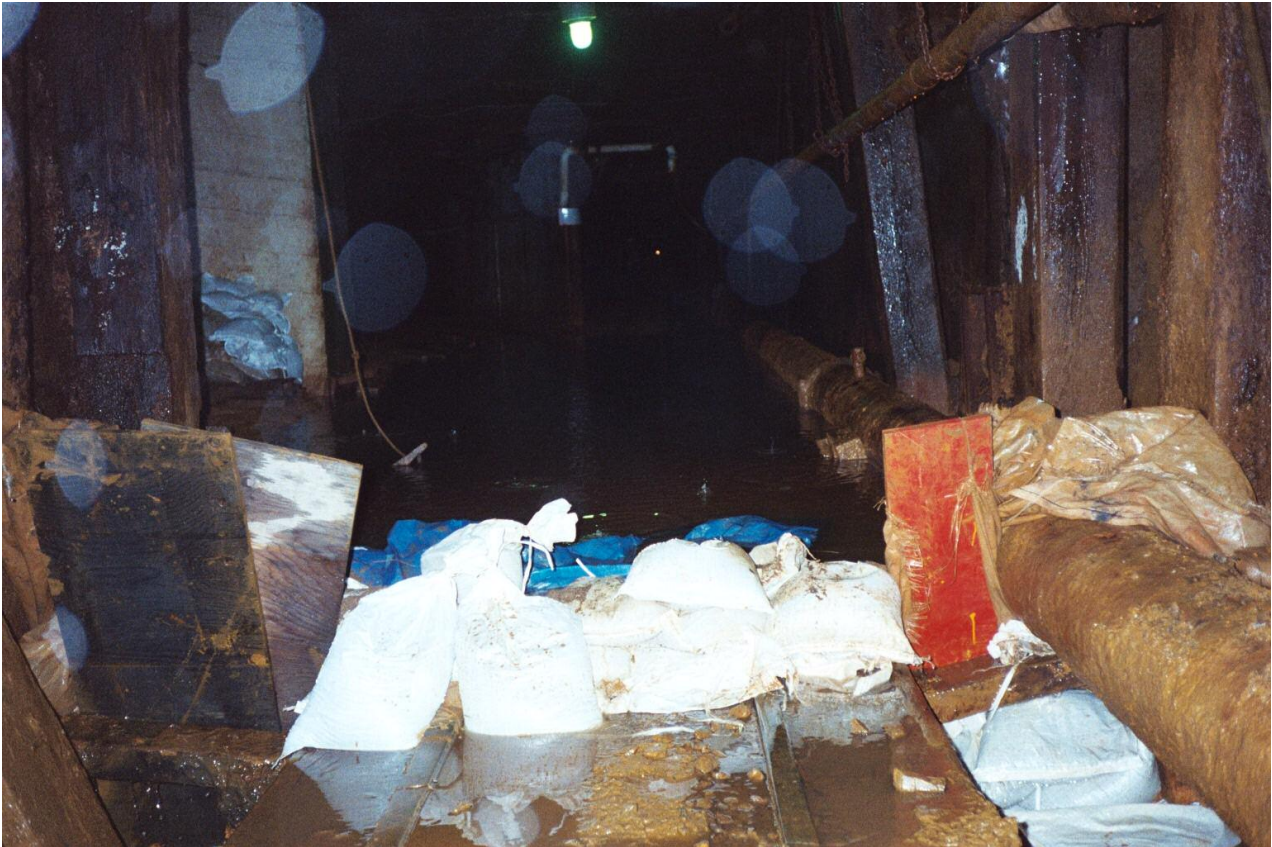
Photo 2

Looking upstream at the trial diversion dam.

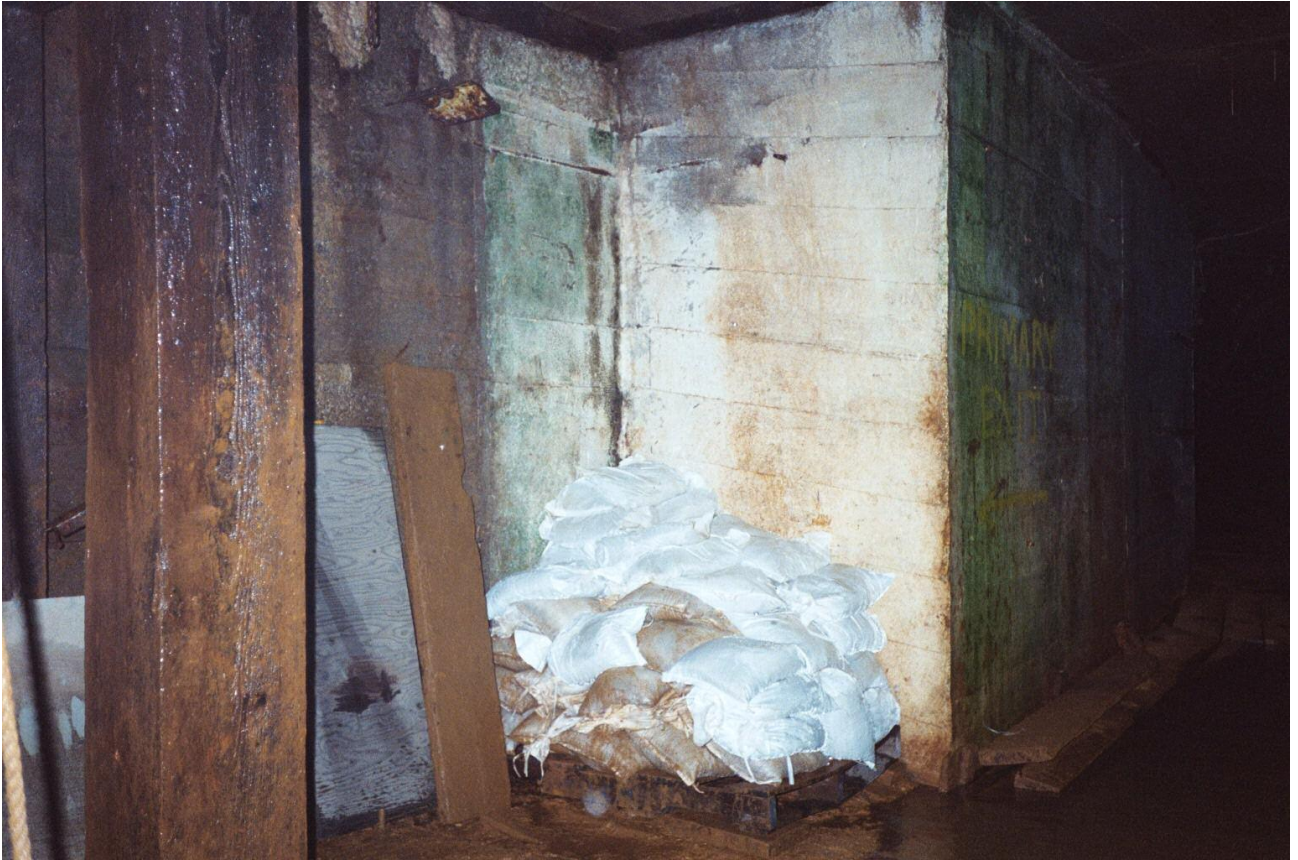
Photo 3

Stockpiled dam building materials located to the side of the dam site. Materials consist of sand bags, boards, and plastic tarps.

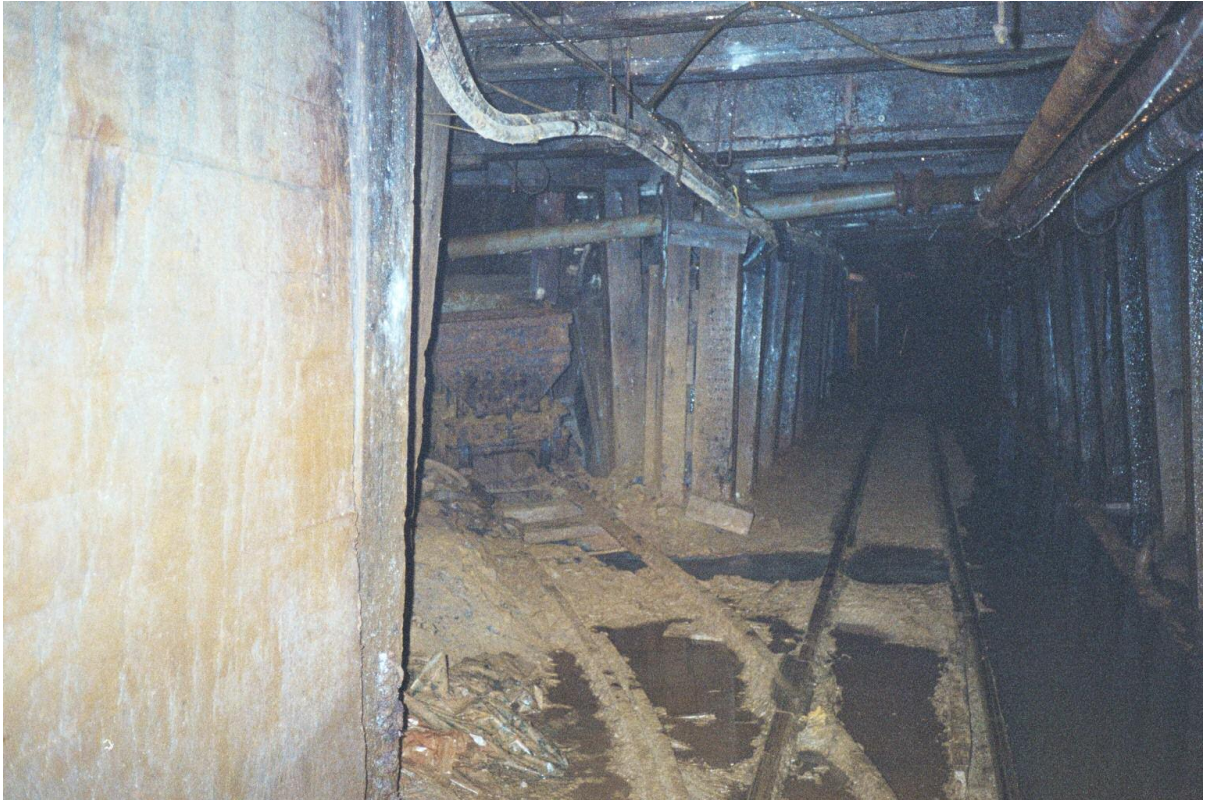
Photo 4

Dammed water backing up the Barney Drift (right side of photo) and draining down the Barney Vent Raise (left side of photo). The top of the raise is located below the old ore car. The trial diversion dam is about 100 feet behind these photos.

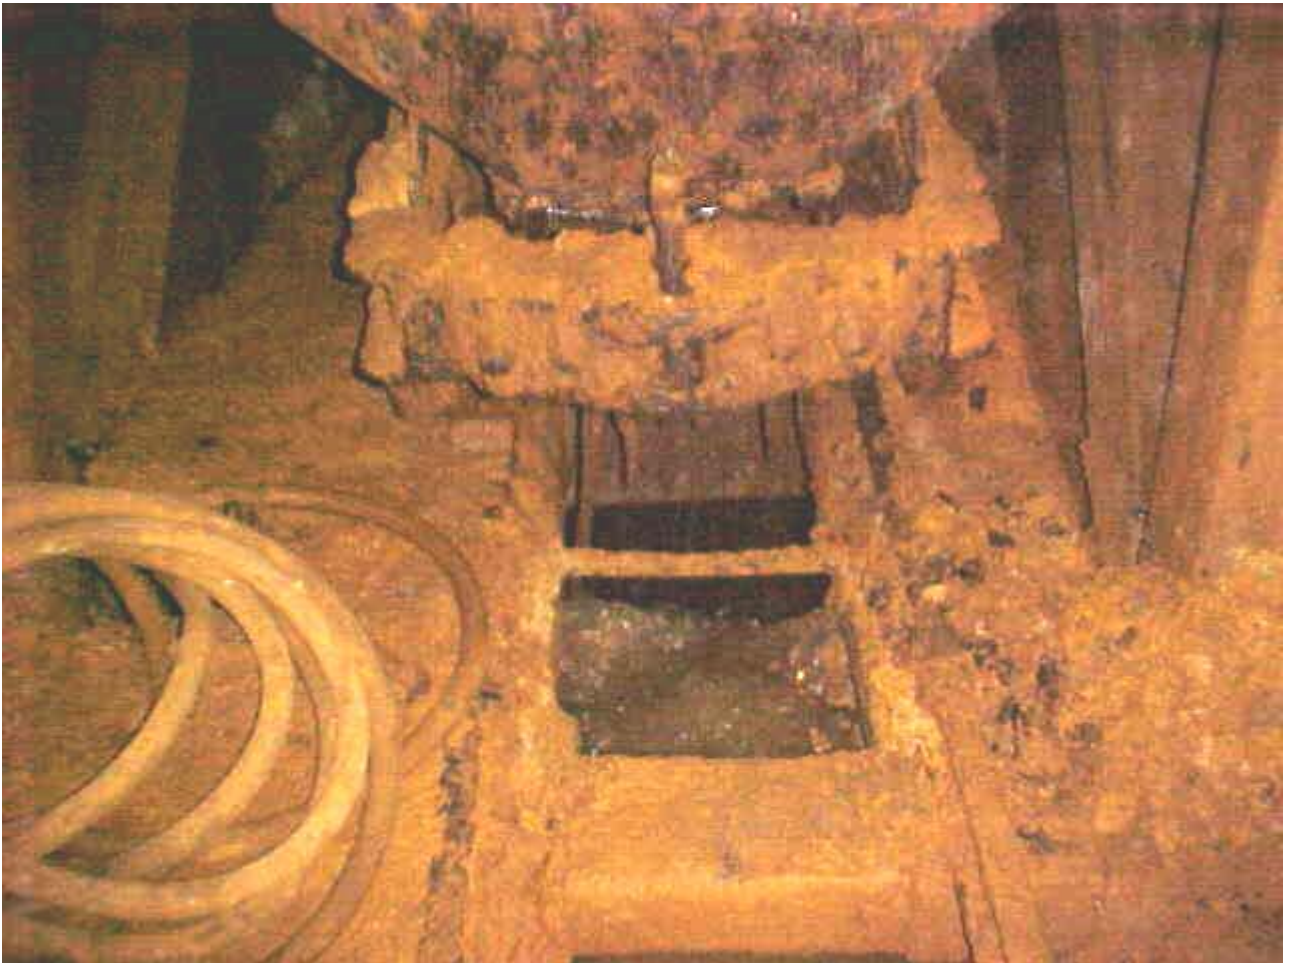
Photo 5

Dammed water draining down the Barney Vent Raise. The top of the raise is located below the old ore car.

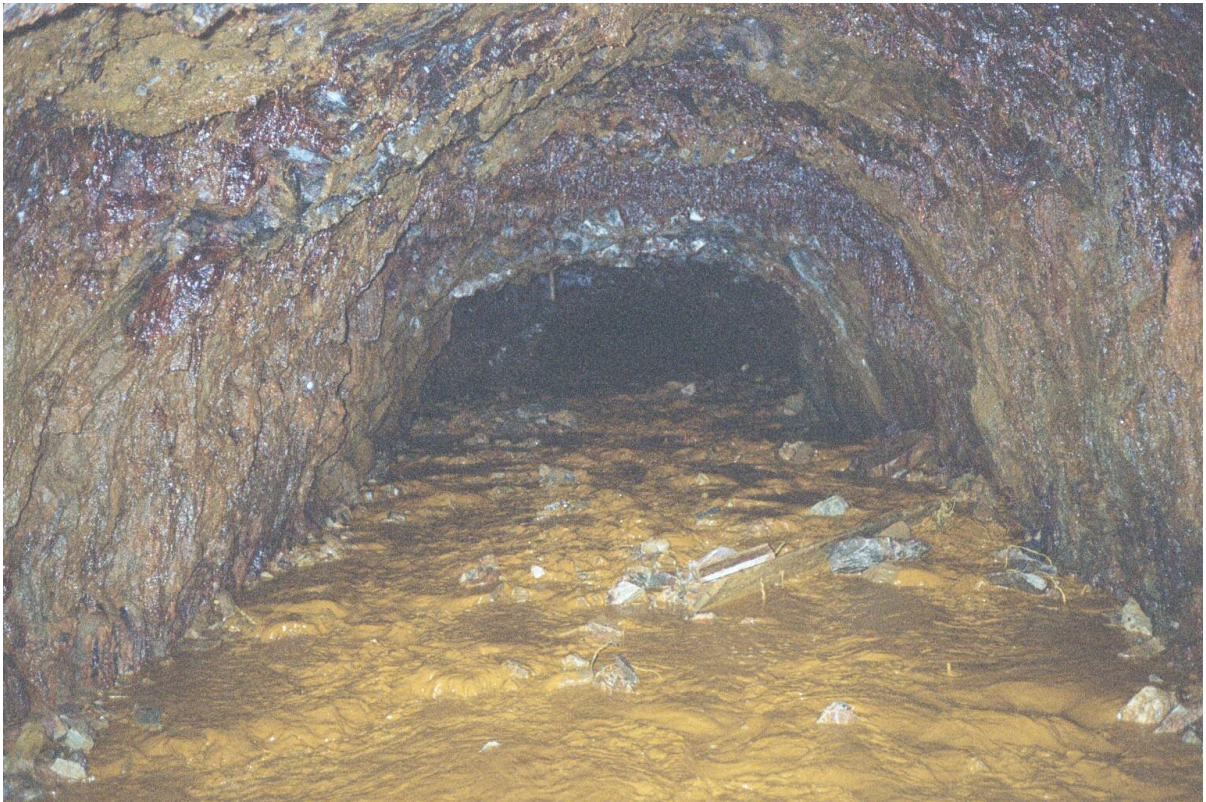
Photo 6

The diverted water flows to 10 Level via the Barney Vent Raise. The New Bunker Hill Mining Company cleaned out the raise over the last three or four weeks through a combination of digging accumulated muck from the bottom and by sluicing water from above. The last sluicing event resulted in a large volume of debris and muck to suddenly flow from the bottom of the raise into the drift on 10 Level. The depth of the debris increases towards the bottom of the raise, and varies from about 1 foot 200 to 250 feet away to within about one to two feet of the drift ceiling near the bottom of the raise. Removal of this debris would be very difficult due to its large volume and lack of rail access. The approach to this area requires a climb down a series of ladders in the Orr Raise, and then wading through water up to three feet deep. There appears to be adequate open space at the bottom of the raise for water flow up to the 7,000 gpm required capacity.

Looking upstream towards the bottom of the Barney Vent Raise on 10 Level. The bottom of the raise is about 200 feet up this drift. The debris and muck in the bottom of the drift accumulated when water, drained into the raise to clean it out, must have built up--then suddenly blew out carrying the debris with it. The diverted water is flowing across the top of the debris and muck. The depth of the debris increases towards the raise. At the back of this drift near the bottom of the raise the debris is up to within one to two feet of the ceiling. Removal of this debris would be very difficult. There currently appears to be adequate open space for water flow.
